Prepared jointly by
University of California
and
University of Chile

FAILURE ANALYSIS OF A REINFORCED CONCRETE FRAME STRUCTURE

TOMAS GUENDELMAN
GARY C. HART
RAUL HUSID

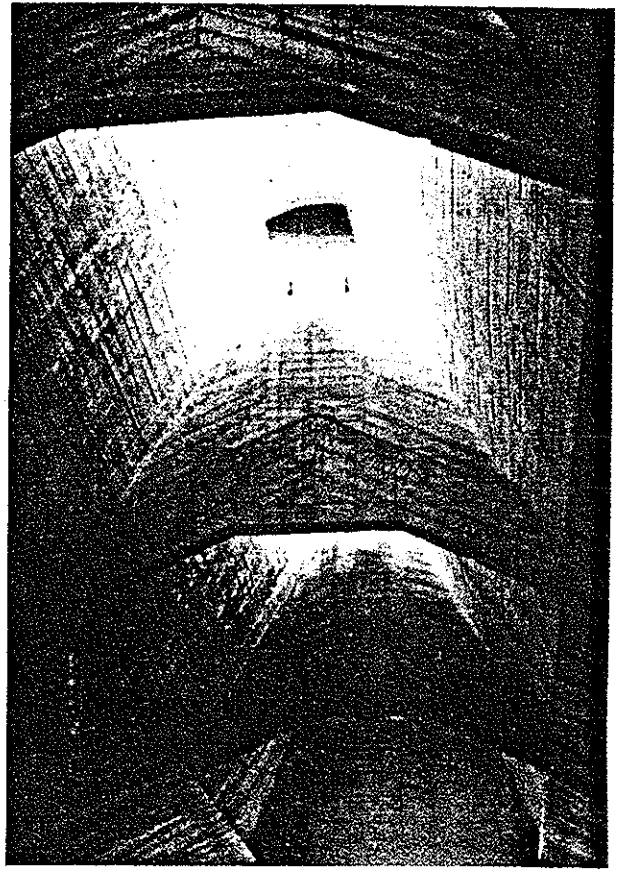
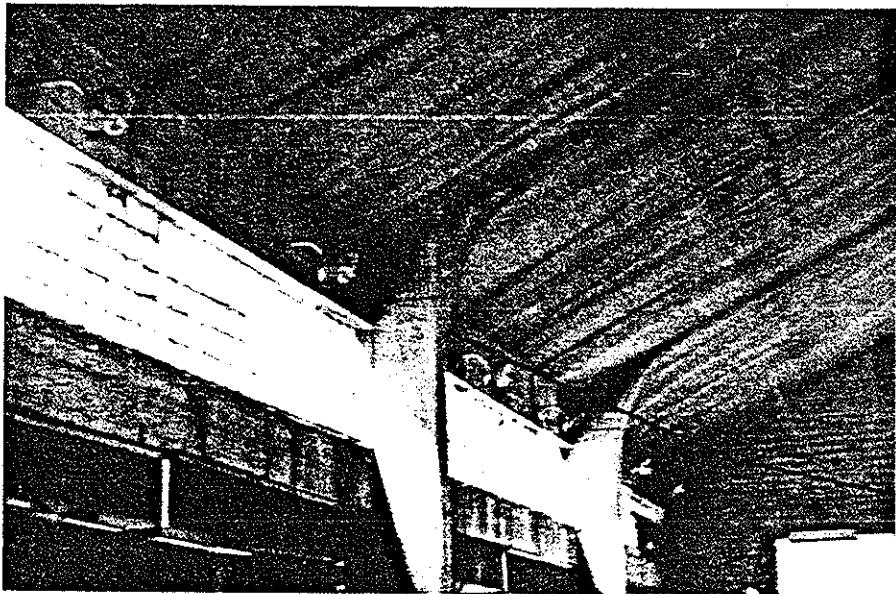
Figure 3. Photographs of Building: Pre-Earthquake

The building discussed herein was constructed in 1946 and is one of two structurally identical reinforced concrete frame buildings. The structures are located within 20 meters of each other. One building experienced only minor visible damage during the earthquake; whereas the other building

suffered complete structural collapse. Figure 2 shows plan and elevation views of these buildings and Figure 3 shows photographs of the building which remained standing after the earthquake.

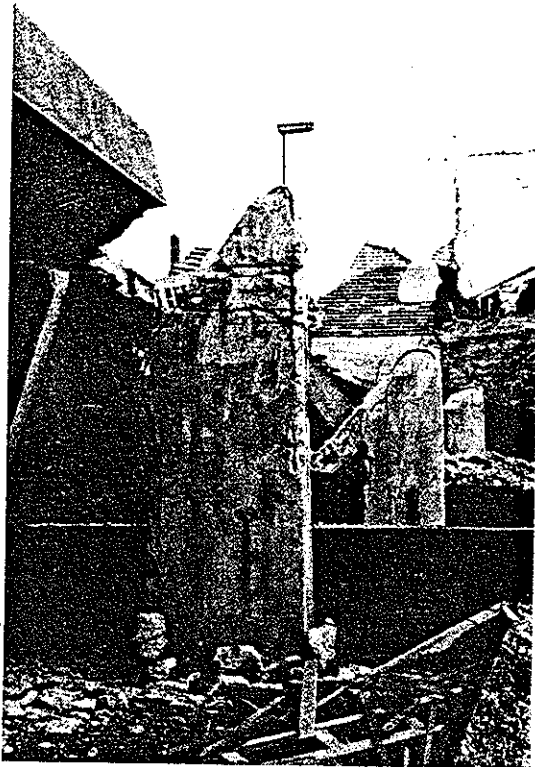
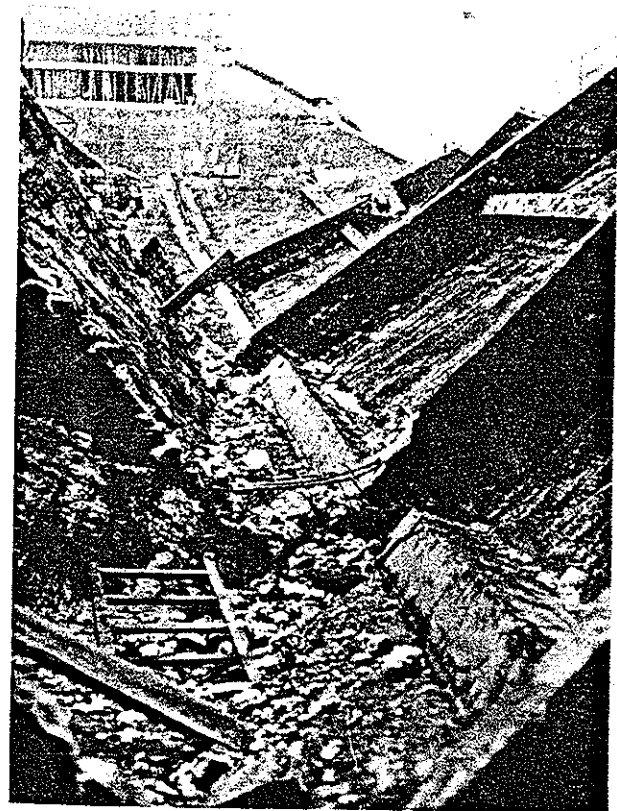
Figure 4. Photographs of Building: Post-Earthquake

The 8 July earthquake caused one of the above noted buildings to completely collapse. Figures 4 and 5 show the post-earthquake condition of the building.

The performance of the formulated analytical structural model and the actual building was quite similar. Structural collapse was predictable from the structural model and hinge locations as postulated from the plastic analysis corresponded to observed failure mechanism.

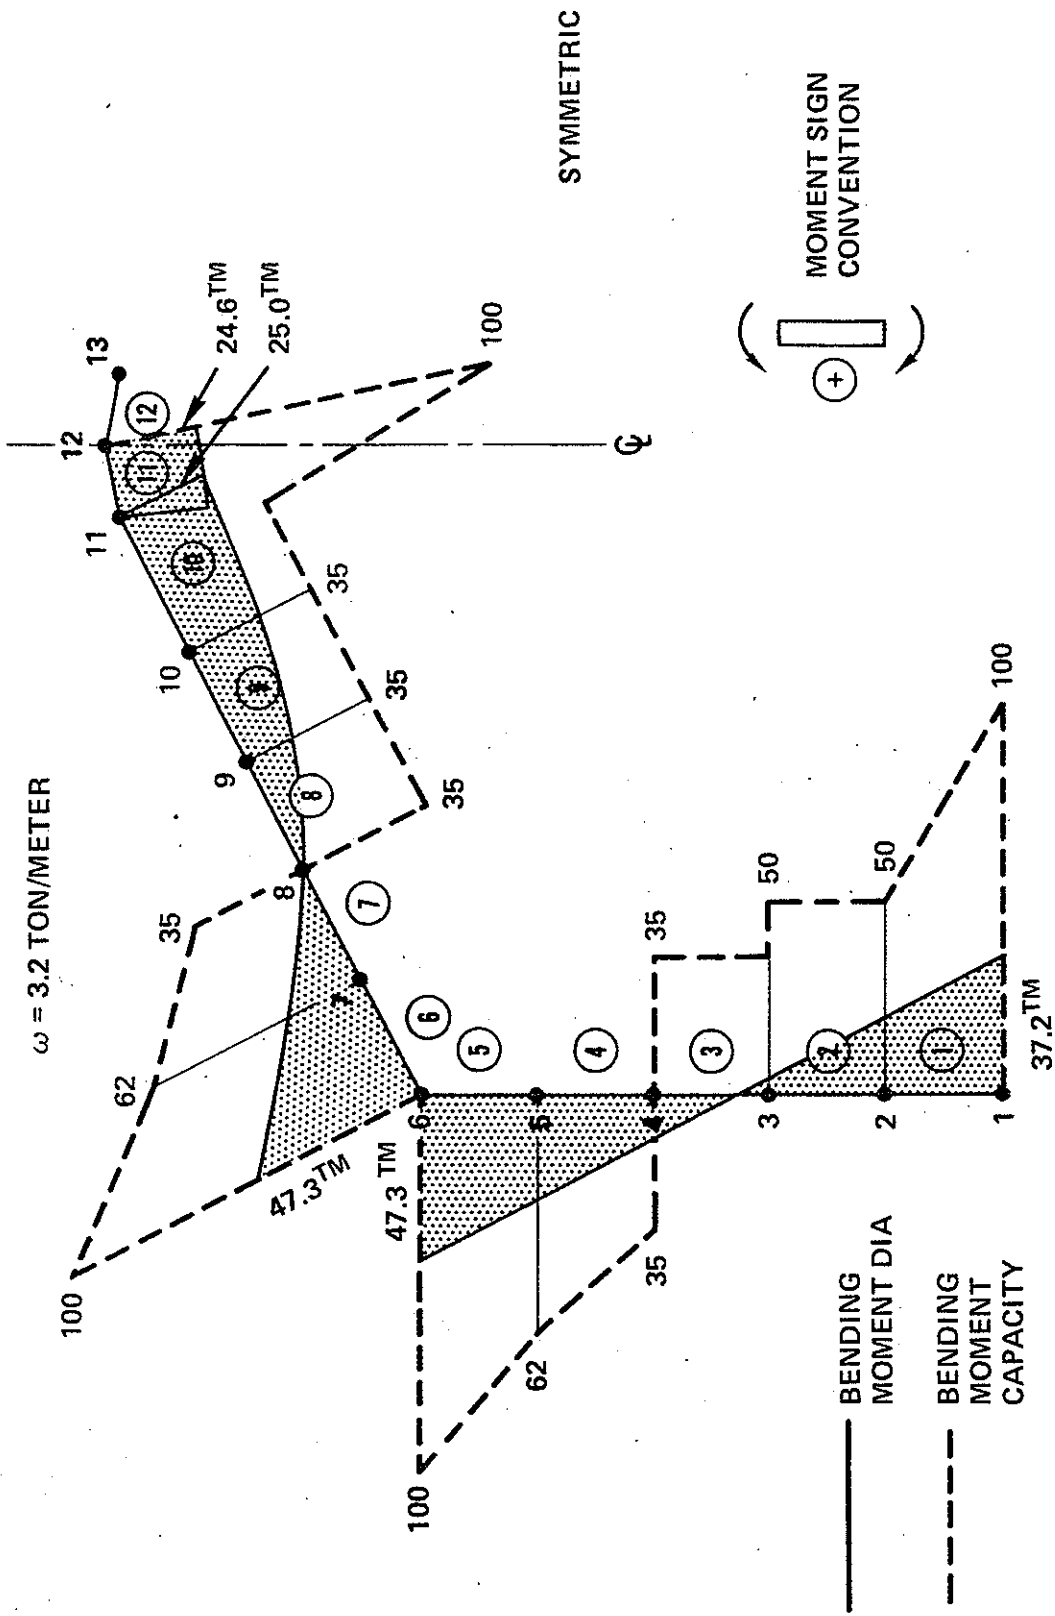
Figure 7. Bending Moment Diagram for Dead Load.

As a first step a static dead load analysis was performed on a typical interior frame. The tributary dead load acting on this frame was estimated to be 3.2 tons per horizontal meter. Figure 7 shows the frame's dead load bending moment diagram. Also shown in this figure is the plastic moment capacity of each structural element.⁽²⁾ It is immediately apparent that the dead load structural moments never approach the structure's plastic moment capacity, and in fact, the dead load factor of structural safety was never less than 2.

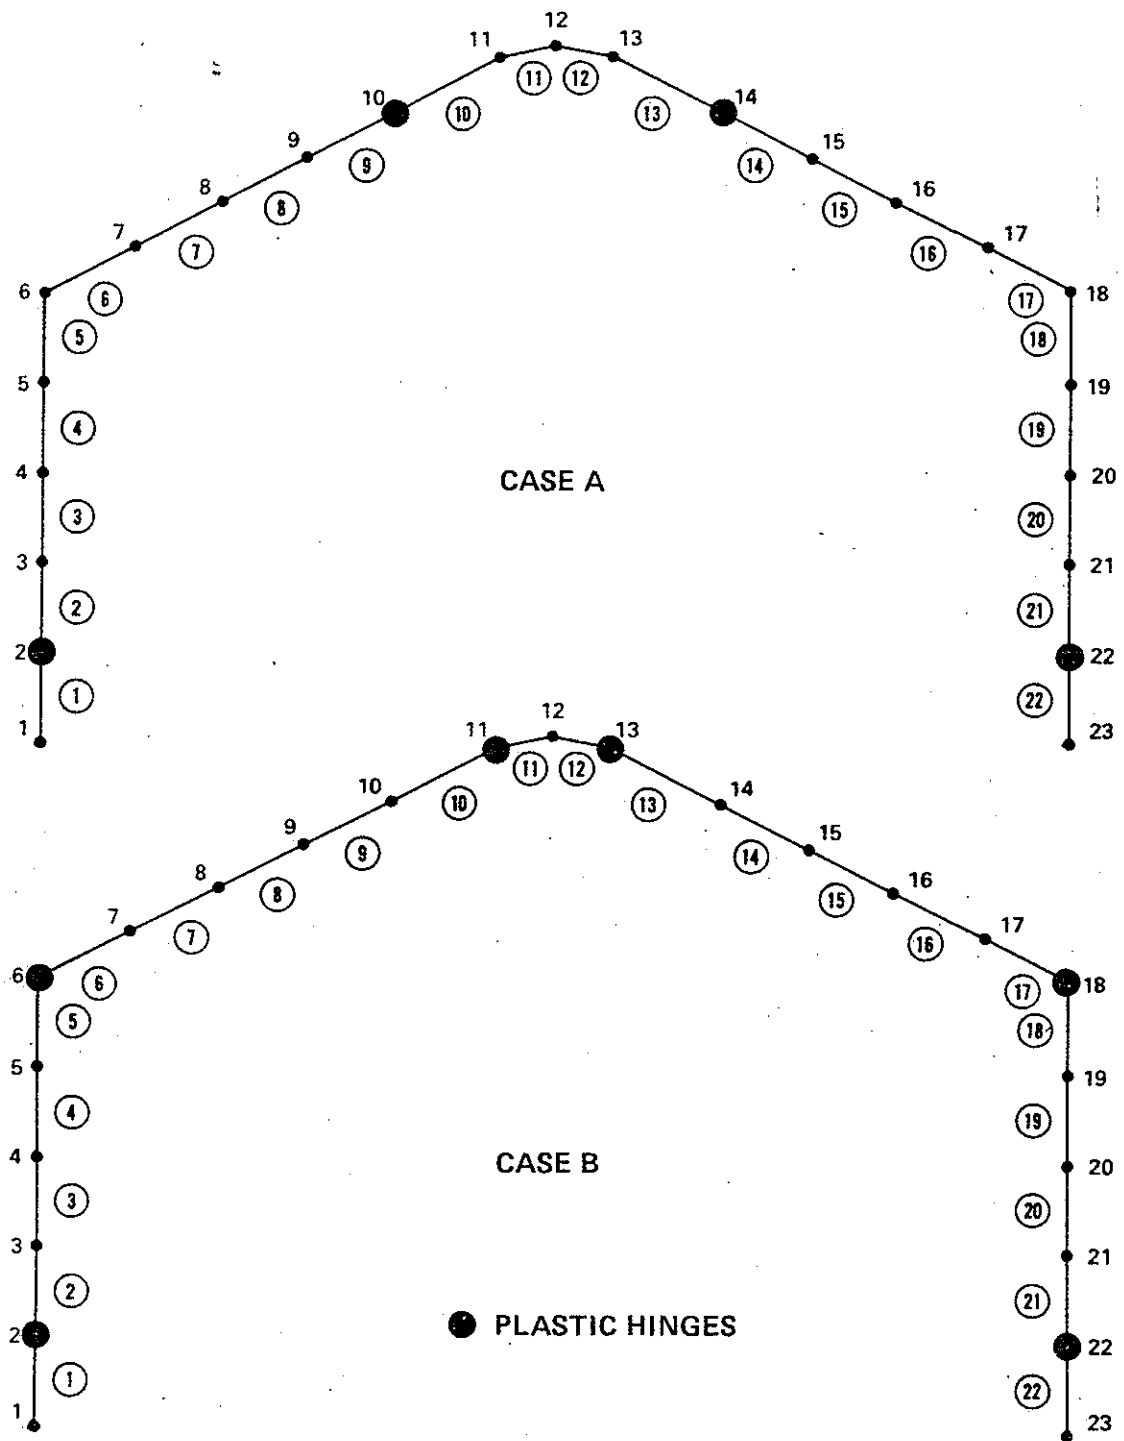
Figure 10. Failure Mechanisms.

Subjected to Case A type loading, the structure formed plastic hinges simultaneously at nodes 10 and 14 when $\alpha = 0.24$. The structure became a mechanism and hence collapsed at the slightly greater loading condition $\alpha = 0.25$. The mechanism of collapse was formed by the development of hinges at nodes 2, 10, 14, and 22. It is important that in this case where lateral

seismic loading was applied to the structure the increment of load necessary to go from first hinge to collapse was only one percent of the structure's weight.

The plastic response of the structure under vertical loading was studied in Case B. Here it was found that hinges were first formed at nodes 11 and 13 when $\alpha = 0.15$. Note that this seismic coefficient is significantly less than that of Case A. However, in Case B it was found that not until $\alpha = 0.52$ did a structural mechanism exist by virtue of hinges forming at nodes 2, 6, 11, 13, 18, and 22. A sketch of this failure mechanism under both of these loading cases is shown in Figure 10.

It appears that the structural failure was a combination of vertical seismic forces which caused the formation of the first structural hinge and horizontal seismic forces which actually caused structural collapse.

This study recommends that seismic codes consider an extension of their static load concepts to include a seismic analysis of the type performed here in. Such an analysis includes both vertical and lateral seismic forces and their influence upon structural behavior.
