Prepared jointly by
University of California
and
University of Chile

FAILURE ANALYSIS OF A REINFORCED CONCRETE FRAME STRUCTURE

TOMAS GUENDELMAN
GARY C. HART
RAUL HUSID

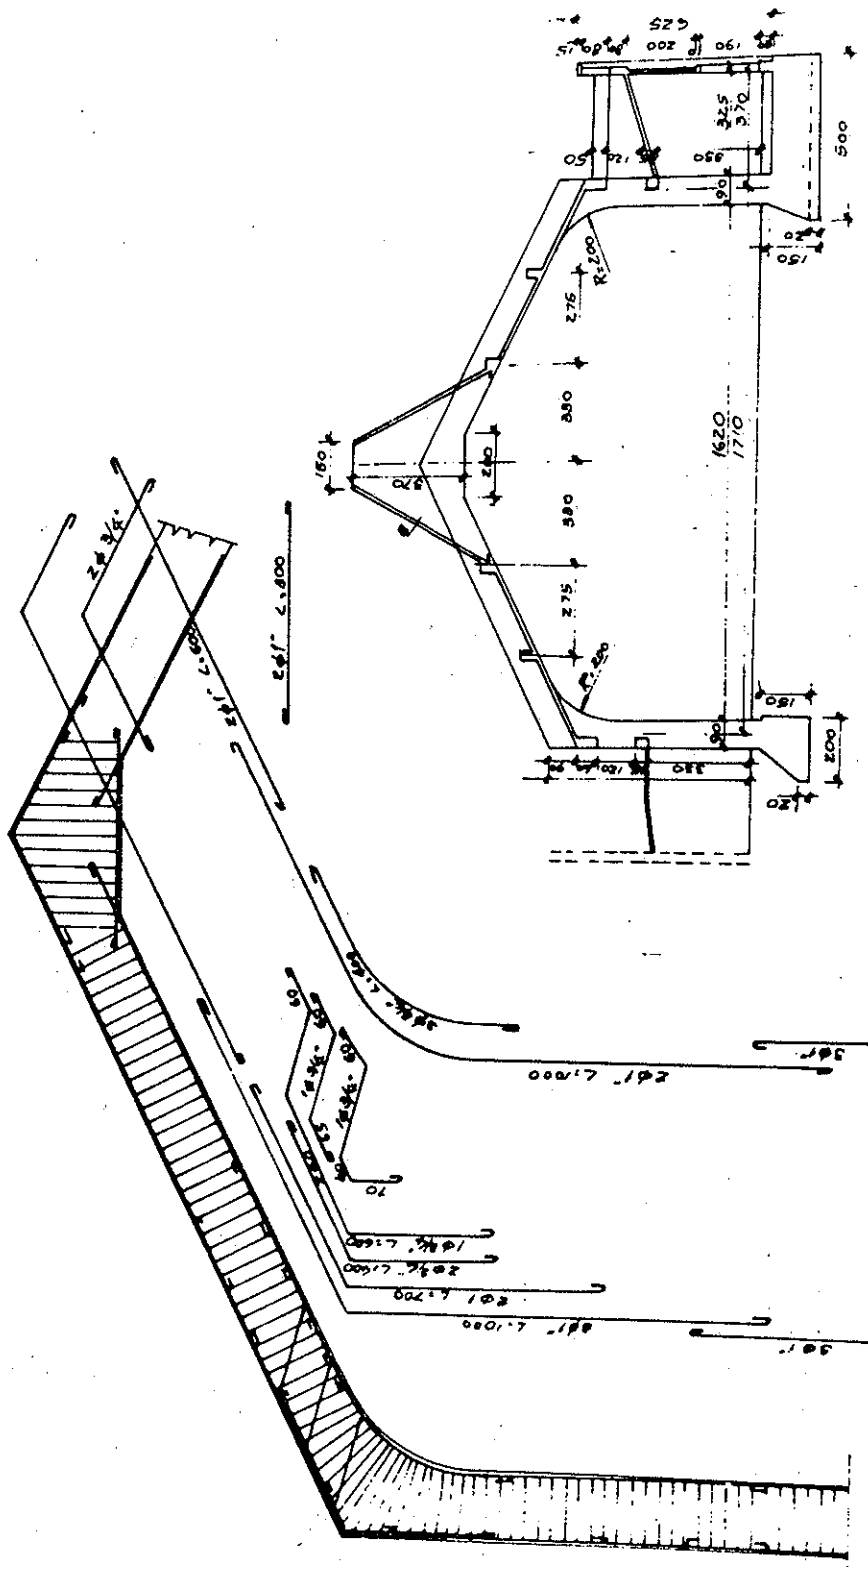
Figure 2b. Elevation of Building.

suffered complete structural collapse. Figure 2 shows plan and elevation views of these buildings and Figure 3 shows photographs of the building which remained standing after the earthquake.

The reinforced concrete frame shown in Figure 2 was analytically modeled by the authors as a two-dimensional planar structure. We utilized the finite element method of analysis to discretize a typical interior frame into a finite number of beam elements, each beam element being allowed to have constant structural properties. It was assumed that the internal deformation pattern of each finite beam element is completely defined in terms of the two perpendicular translational and one rotational degree of freedom at its ends.

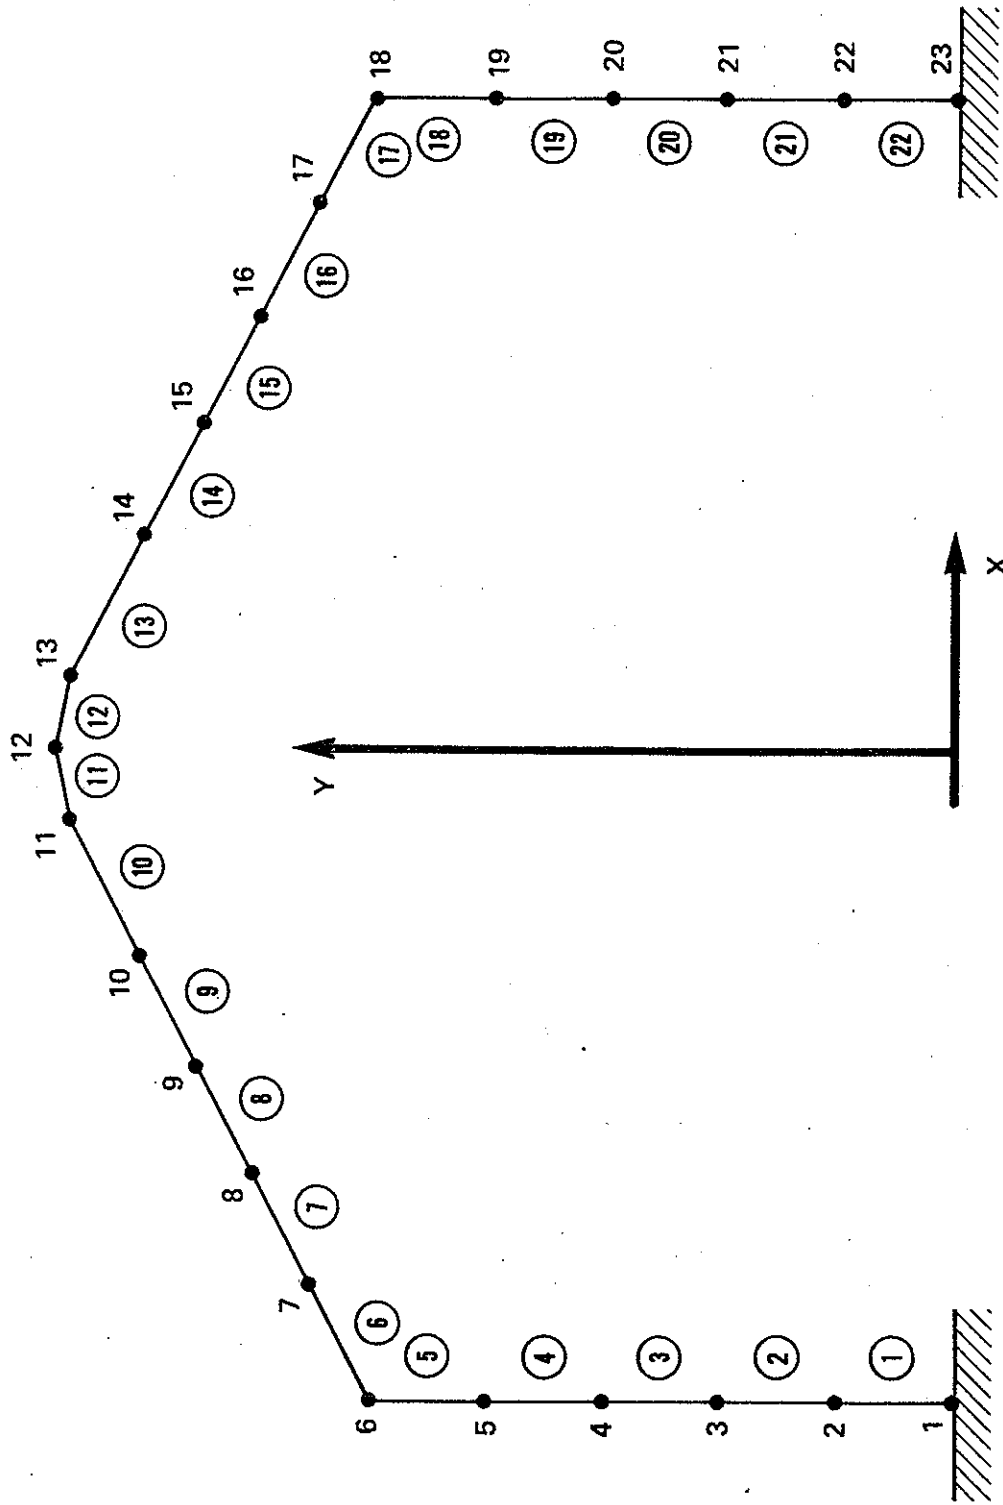
Figure 6. Structure Definition. Joint, Members and Coordinates.

Figure 6 shows an elevation of the structural frame and the 22 beam finite elements comprising the analytical model. All finite beam elements except numbers 11 and 12 were assigned equal structural properties, see Table 1.

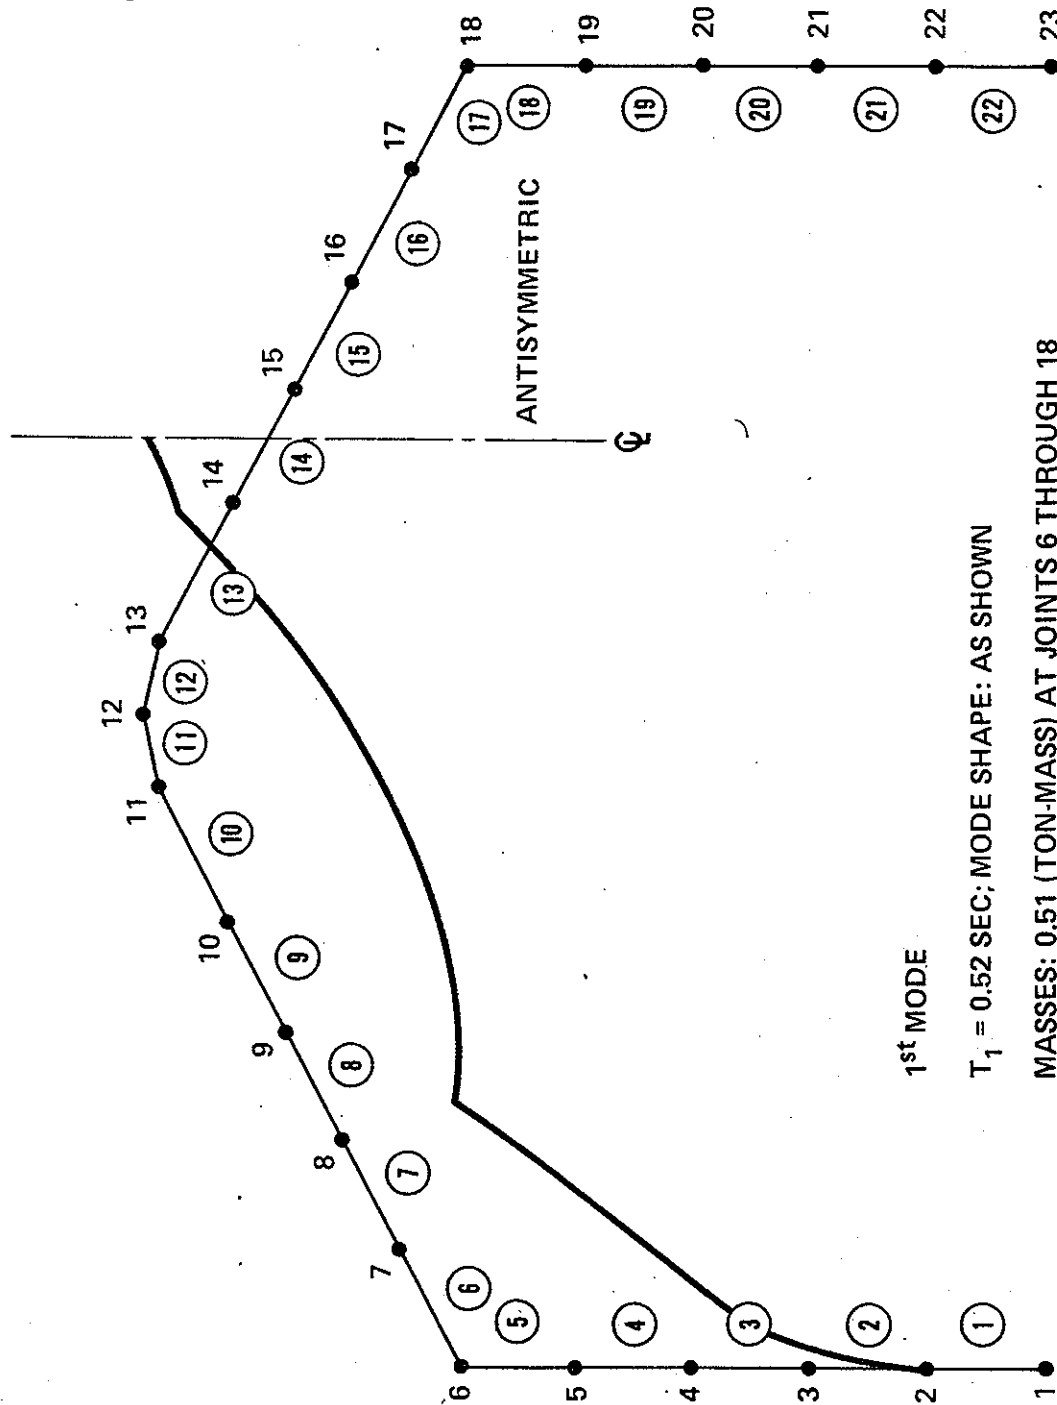
Figure 8. First Mode Shape.

Table 2 lists the frame's first six natural periods of vibration and Figure 8 shows its first antisymmetrical and symmetric mode shapes.

$T_1 = 0.52 \text{ SEC}$; MODE SHAPE: AS SHOWN

MASSES: 0.51 (TON-MASS) AT JOINTS 6 THROUGH 18

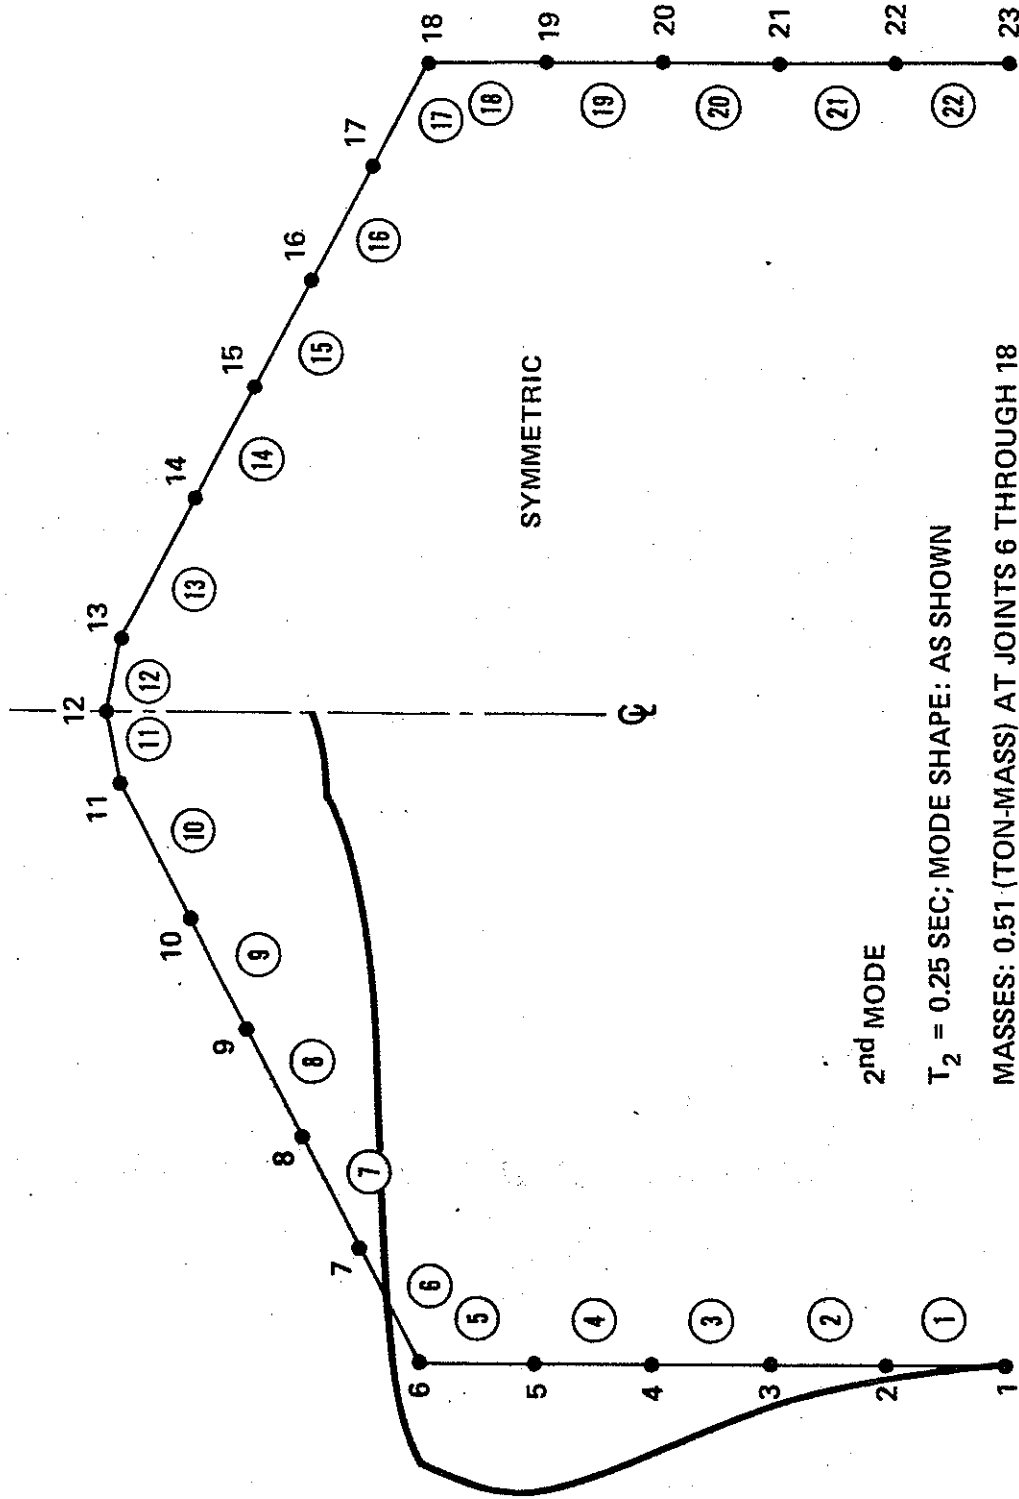
Figure 9. Second Mode Shape.

First and second mode shapes are shown in figures 8 and 9.
